From: "Hardy, Russell" <RussellHardy@consolenergy.com>
To: "Hardy, Russell" <RussellHardy@consolenergy.com>, <pamgrubaughlittig@uta...>
Date: 11/21/2007 2:59 PM
Subject: Emery Subsidence Report
Attachments: Emery Subsidence 11-19-07.pdf

Consolidation Coal Emery Mine Subsidence Report for October 2007

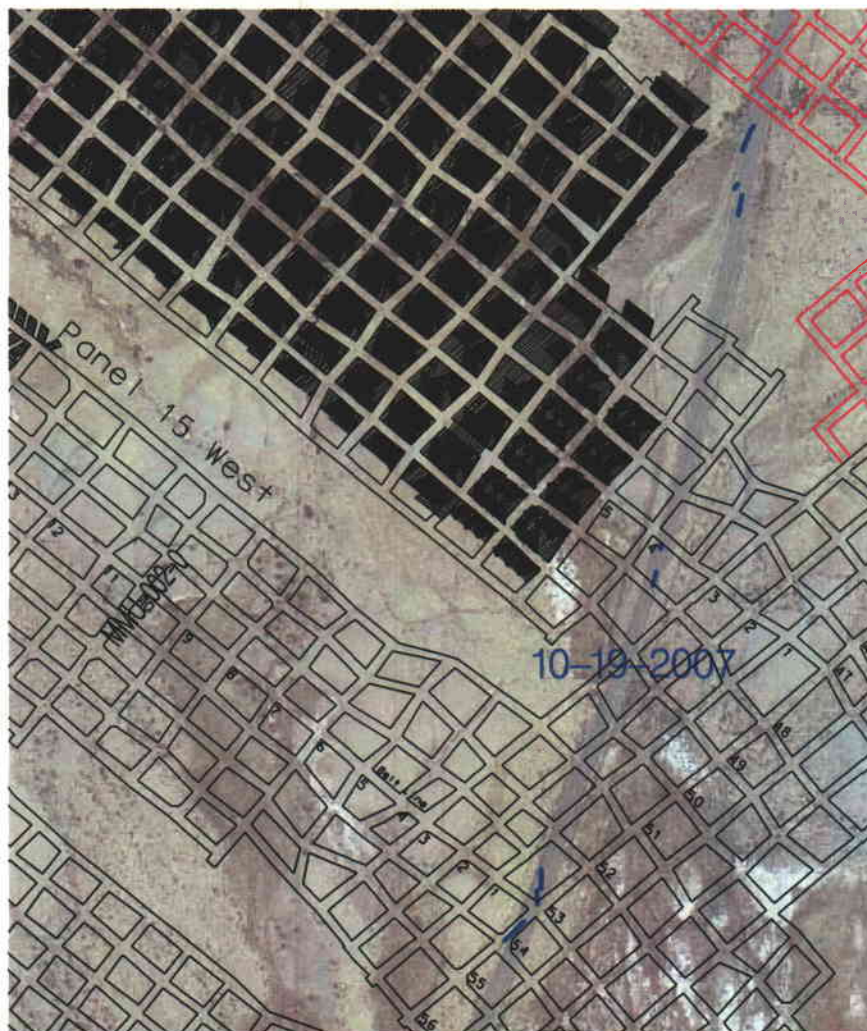
10-19-07 Panel 14 West - Walked road and powerlines. Noted noticed some cracks on the road and don't know if they are subsidence or not. GPS cracks. PB
0 North - No cracks over 0 North. Pillaring began today. PB
